JAISALMER FORT

THIRD TECHNICAL MISSION

IDENTIFICATION OF A PILOT PROJECT

January 8–17, 2001

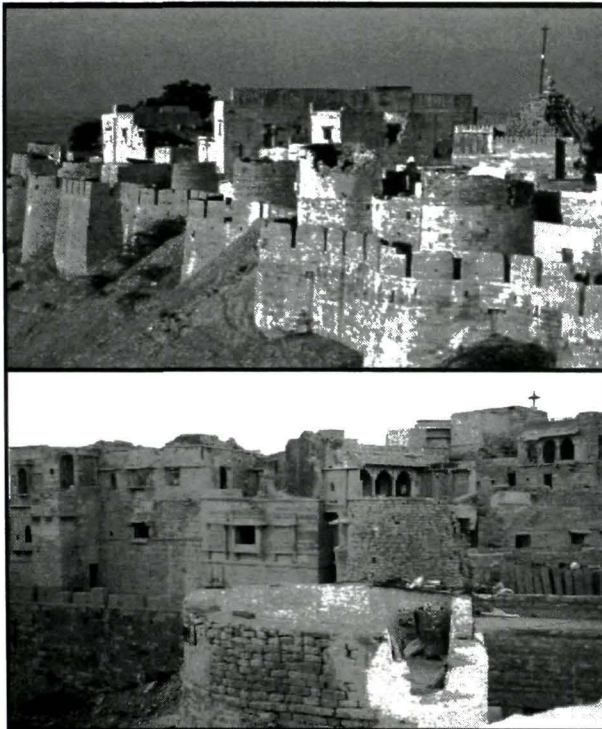
PHOTOS 4 & 5

The present state of the sandstone bastions circumscribing the Fort ranges from well preserved to seriously endangered. While a few on the eastern face are in fairly good condition, most others show signs of severe damage. As mentioned earlier, two bastions collapsed entirely during the rains in 1999. Some others are showing signs of imminent failure, with bulging base walls and crumbling stone blocks. Several bastions have been illegally occupied and converted into residences, thereby subjecting them to loads they were not intended to sustain. In some places, the crenellations have been incorporated into extended walls, which, in addition to being visually inappropriate, create a potentially dangerous situation for the residents and the people in the surrounding areas. A few bastions are disintegrating, partly due to weathering and partly due to the removal of their stone blocks for use as building material by the residents.

A general view of the east range of the fort's upper slope and bastion walls, top. Additions made to the inner bastion walls during hotel construction, below, have compromised the fort's profile and increased pressure on wall foundations.

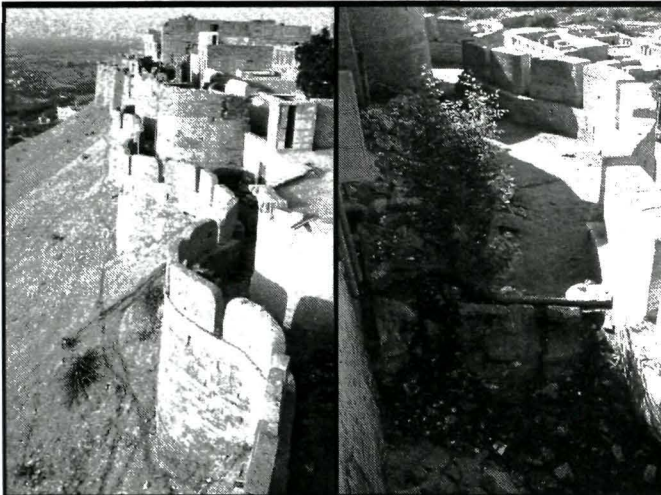
PHOTOS 6 & 7

The *Mori* is the narrow passageway between the inner and outer bastions walls that meanders around the perimeter of the fort. Designed primarily for defensive purposes, the *mori* also functioned as the fort's main drainage conduit for storm-water during monsoons. Today, the most serious concerns relating to the *Mori*'s condition is its use as a latrine by residents without toilet facilities and the widespread habit of using it for the disposal of household garbage. This has had a severe impact on its condition, keeping it from serving its original drainage function. The paving in the *Mori* is uneven or missing altogether, with no signs remaining of the original outward pitch for effective drainage. There are innumerable mounds of rubble and discarded building material, which further obstruct the flow of water to the outer wall, thus forcing it into the ground below. The increasing moisture in the *Mori* has also encouraged the growth of vegetation, whose weight and root structure will, over time, lead to total disintegration of large sections.

A view down into a section of the Mori's passageway, left, which was originally designed for defensive and drainage purposes. Drainage outlets, right, are blocked by household refuse and unchecked vegetation.

1. Cleaning and repair of Mori: In order to restore structural stability and prevent water accumulation, the Mori and its drain outlets should be cleaned of debris and the collapsed portions rebuilt as soon as possible.

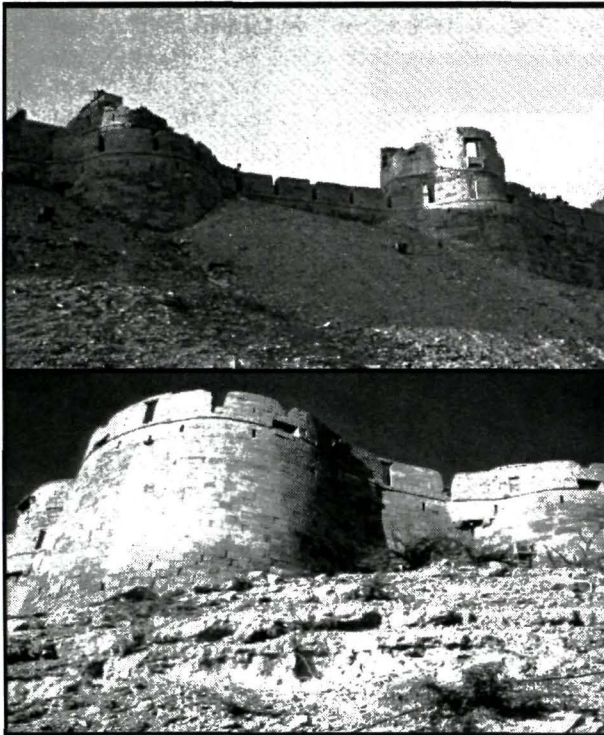
PHOTOS 8 & 9

Several sections have failed due to the uneven settling of the soil underneath, caused by moisture percolation. Due to the dumping of garbage over the slope, the outer wall has become buried under the accumulation, in several places almost entirely. Conversely, in other locations, the base of the wall, which was intended to be covered, has been exposed due to the erosion of the slope. The rough-hewn, unfinished stone so uncovered has failed in many places from contact with the elements. There are many instances where entire blocks of stone have disintegrated or dissolved, leaving large holes in the wall. The outer wall is also under serious threat by the rampant growth of vegetation, particularly the *Peepal* tree (*Ficus religiosa*), which tends to have an extremely invasive and damaging root system. Some bastions, especially on the eastern side, are buried under years of accumulating garbage.

Sections of the outer bastion wall, top, are covered by garbage and sandstone construction debris dumped over the years. Foundations of the circular bastions, below, have been eroded by wind and rain.

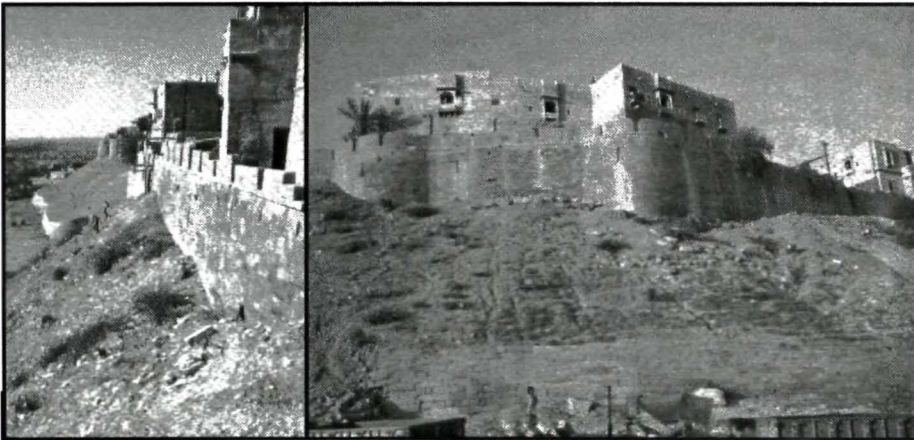
PHOTOS 10 & 11

On all sides of the fort, the slope has suffered considerably from erosion and the continuous dumping of trash over the years. Although it is likely that this had been the practice throughout history, until recently the amount generated by the residents tended to be small and entirely organic. Lately, however, both the amount and nature of the refuse have changed, with non-biodegradable materials (plastics, metal, styrofoam, etc.) forming a large part of the debris. These tend to remain in place for extended periods of time, a process exacerbated by the greatly reduced occurrence of sandstorms, which would previously disperse the debris over a larger area. Significantly, much of the garbage today appears to be generated by tourists or tourism-related industries, such as plastic bags, film canisters, mineral-water bottles, etc.

The condition of the slope has also been seriously compromised by erosion caused by wind and water. As mentioned earlier, this has exposed the base of the wall in many places. The increasing precipitation has washed away much of the upper layer of the slope, while facilitating vegetation growth. This fact is doubly destructive, since plants tend to further retain water within their roots, beginning a cycle of deterioration. The erosion is exacerbated by the animals and rag pickers who climb the slopes several times a day to forage amongst the garbage dumps.

An increasing amount of non-recyclable material has been dumped over the bastion walls, left. Monsoon rains have carved gullies that funnel water down the slope, some of which collects behind the pitching wall.

5. Repairing of the slope: Efforts should begin to reclaim the original character of the surrounding slope by restoring the correct profile and pitch. Although this is not a goal that can be accomplished in a short period of time, work should be initiated nevertheless on the worst affected areas. These would include sections with the most severe erosion as

well as those with the most debris accumulation. This is important because the correct gradient of the soil (greater than 32°) will significantly increase water runoff from the slope and minimize seepage into the soil, thereby forestalling much damage in the future, most notably to the already suffering Pitching Wall.

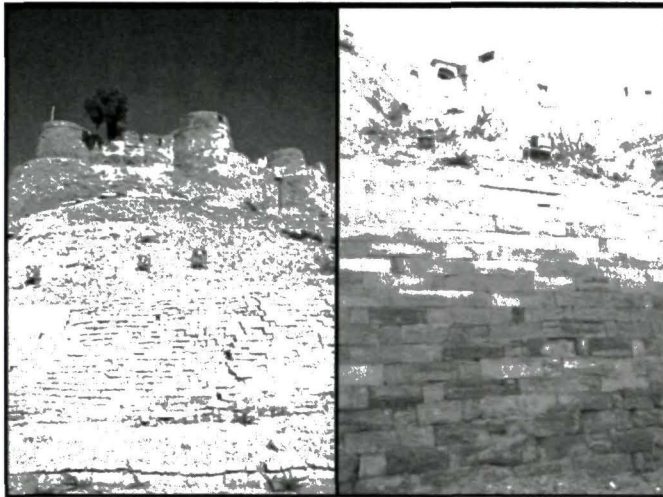
PHOTOS 12 & 13

Due to its exposed position and considerable length, the Pitching Wall has seen much damage to its original form. It is of dry masonry construction, and ranges in height from 6 meters to 10 meters. Since it was originally intended merely to maintain the slope above it, it was not designed to withstand any lateral loads. The erosion of the slope, however, along with the seepage of water into the subsoil, subjects the wall to tremendous outward pressure, which it has been unable to withstand. It has collapsed in several places, and the rebuilding of the Pitching Wall is an ongoing work for the ASI. Often, the stones of the Pitching Wall are seen bulging or shifting, and some sections are visibly moist and wet. As in other parts of the Fort, the moisture has led to a complete dissolution of some blocks. In recognition of the changed situation and function of the wall, the portions being rebuilt by the ASI are provided with concrete footings and are designed to serve as retaining walls.

As the clay absorbs water, the increased weight exerts pressure on the pitching wall, left, resulting in shifting and cracking. Dark sections of the pitching wall, right, attest the presence of moisture in the sandstone veneer and clay-stone behind it.

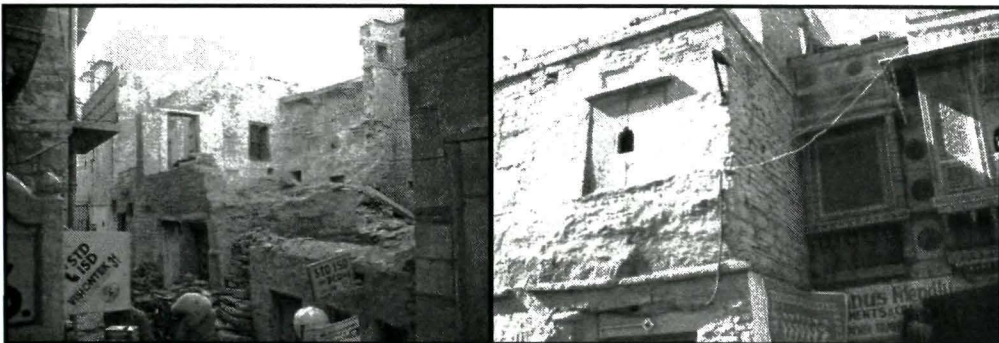
PHOTOS 14 & 15

- a. The most pressing concern about the historic monuments is structural failure, brought on by the settling of the subsoil caused by water seepage. Since the buildings were traditionally built of dry-masonry construction and without foundations, they have been unable to withstand lateral loads of even the smallest degree. The instances of building collapses have shown a marked increase during and immediately following the rains every year.

- b. In some of the smaller private houses, the structural failure is often caused by unauthorized construction, with the residents building upon existing walls indiscriminately. Much of this additional construction has been to cater to the growing tourism industry, and is in violation of ASI guidelines for protected monuments.

- c. The aesthetic value of the buildings is also being compromised rapidly. The new construction is of mediocre quality and substandard in materials and workmanship. There is an increasing tendency to use brick and cement for construction, instead of the sandstone blocks traditionally used. There are large, unsightly hoardings and billboards all over the city. Not only are they visually offensive, they also conceal the elegant facades of the buildings, in some cases even disfiguring them. The grand and ceremonial identity of spaces such as *Dassehra Chowk* has been completely overwhelmed by the riot of signs promoting hotels, restaurants, souvenir stores and lately, e-mail services.

Collapsed buildings, left, collect rainwater, which migrates to and undermines adjacent foundations. Traditional facades are marred by the use of inappropriate construction materials such as concrete block and portland cement.

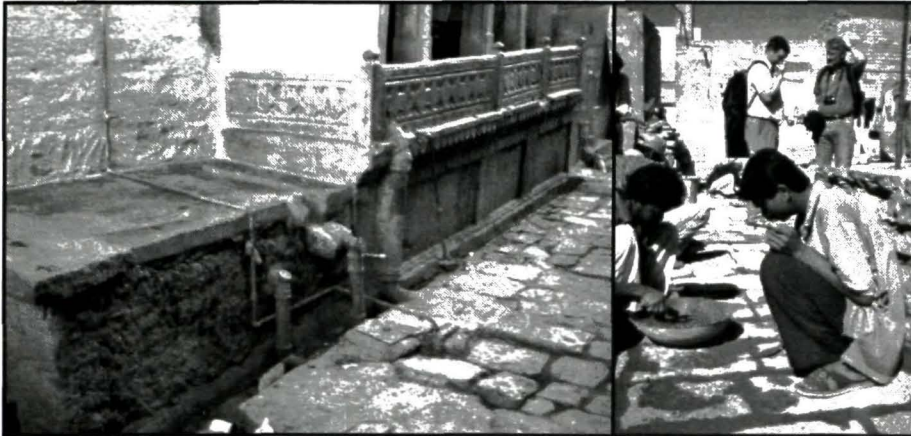
PHOTOS 16 & 17

Most of the original paving in the streets throughout the Fort is in a greatly compromised condition. The stones have come loose and are generally uneven; they show signs of erosion after centuries of use. In some areas, an effort is being made to improve the condition of the streets by the laying of new dressed pavers that replicate the original configuration. The team visited Vyaasa Pada, a square within the Fort, where a project is underway to pave the street and alleyways, after incorporating new sewage and water disposal systems. This work is an undertaking of Jaisalmer in Jeopardy, a non-governmental organization that has been actively supporting the restoration of the Fort and the town.

Ad-hoc repairs to municipal water and sewage connections and telephone lines, left, have damaged paving stones. Workers, right, install paving stones using a traditional lime mortar mix.

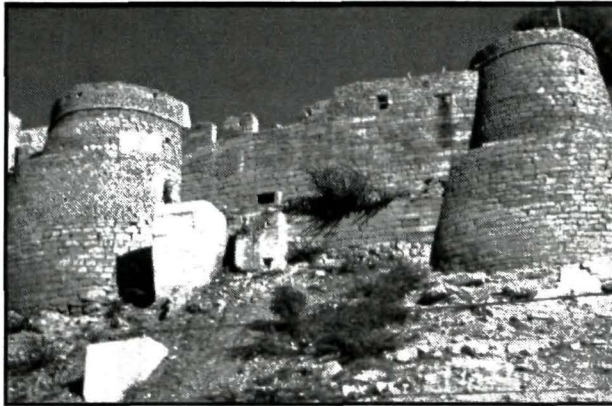
PHOTO 18

One of the original four storm drains is visible in the west bastion wall above modern concrete sewage chambers.

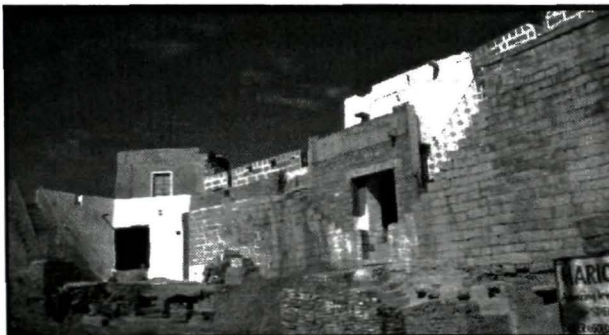
PHOTO 19

Houses have been built inside the south-west bastion corners within the WMF proposed pilot project area.

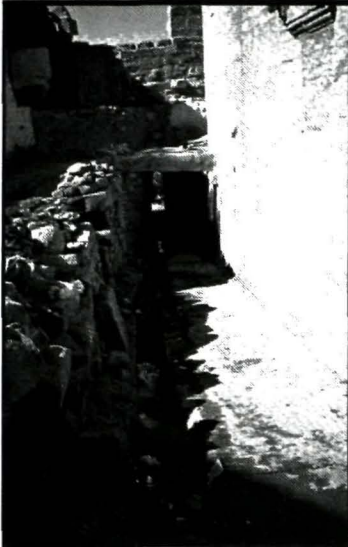
PHOTO 20

Open street drain within the proposed pilot area feeds into an original storm drain outlet in the bastion wall.

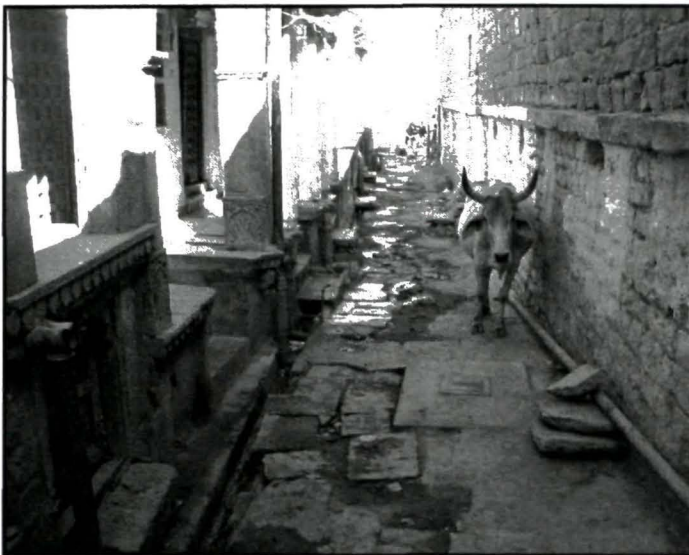
PHOTO 6.2.2.1

Leakage from the water supply system and malfunctioning drainage systems leads to stagnant water in many streets.

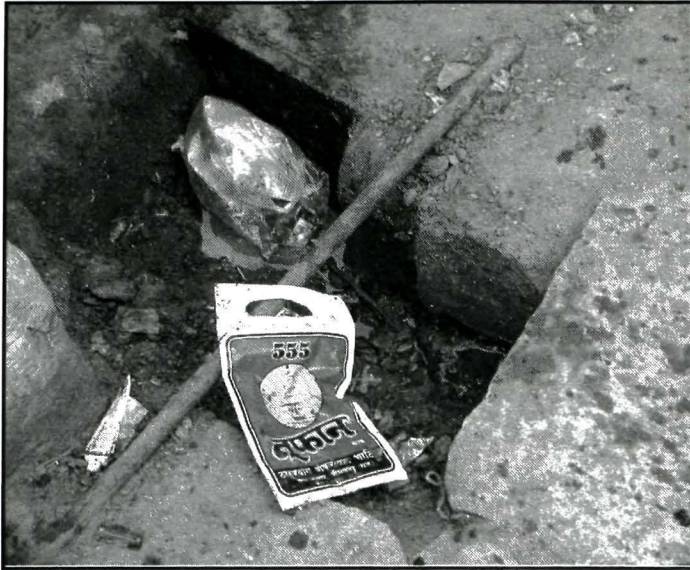
PHOTO 6.2.2.2

Garbage and plastic bags clogging the drainage system.

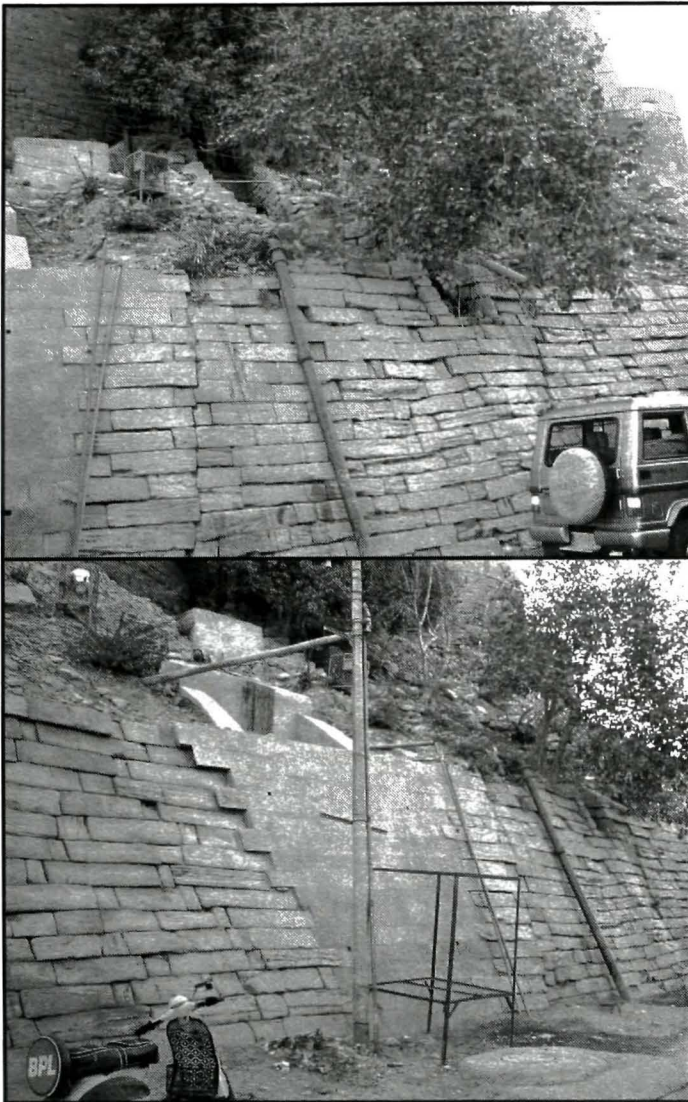
PHOTOS 6.2.2.3 & 6.2.2.4

The original outlets have now been redesigned and a series of new, dull looking, concrete sewerage chambers, built on the slopes above the pitching walls have been added, incorporating both the sewerage and storm water. The sequences of chambers at each outlet are interconnected through a sewerage pipe that is obviously too small for the combined flow of sewerage and storm water in case of heavy rains.

Original storm channel opening in pitching wall above vehicle on the slope and the new chambers for sewerage and storm water.

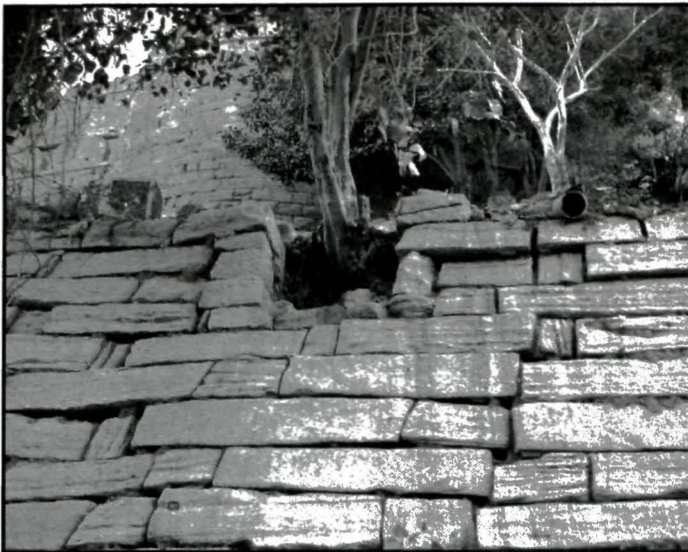
PHOTO 6.2.2.5

Original storm channel on the slope. Vegetation and garbage now block the channel.

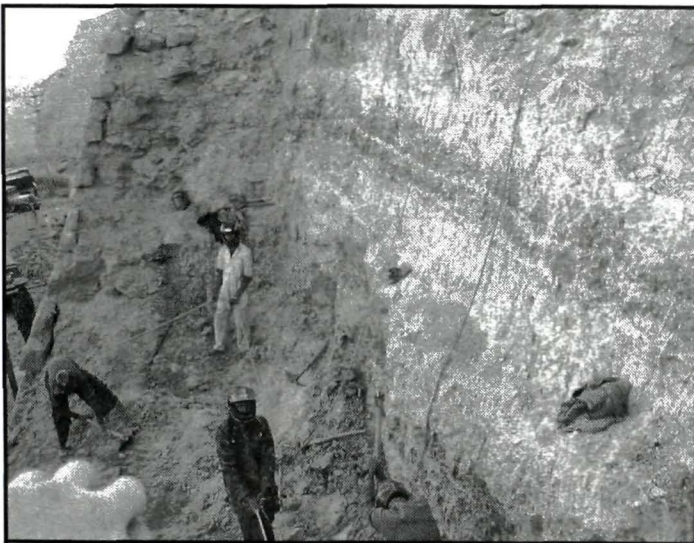
PHOTO 8.2

Repair of broken part of the pitching wall. The rock is a claystone, which can be excavated with pick-axes, The layers of sand can be seen inbedded in the claystone.

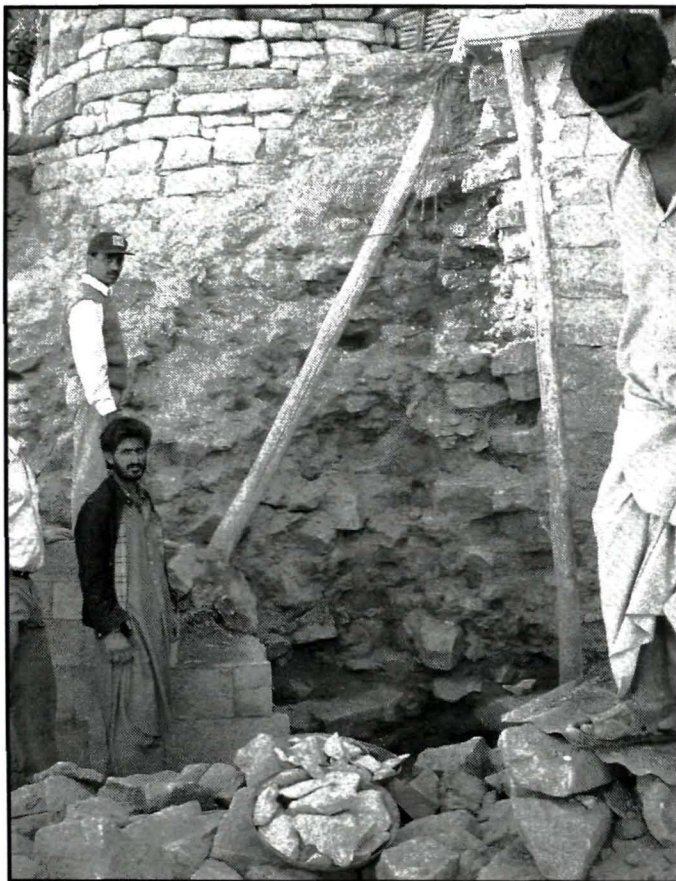
PHOTO 11.1.1

The bearing pressure on the sandstone and clay stone under the bastions and the walls has increased due to the additional structures, mainly new hotels, that have been built in the Fort during the last decades. These additional loads in connection to the weakening factors described below are a threat to the stability of the Fort.

Repair of collapsed bastion

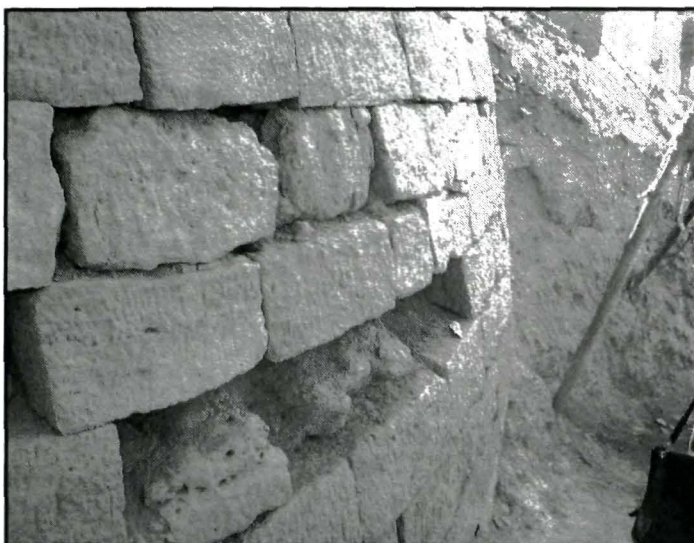
PHOTO 12.2

The sandstone is a sedimentary rock and it often contains layers of coarser or finer materials. In some building stones of lesser quality these layers are more frequent and bigger than in others of better quality. It can be seen in the masonry walls that the stones of bad quality have been highly eroded. Sometimes entire stones are missing in the walls. The erosion is caused by water seepage and by wind. If one or more of these bad quality stones have been used near the bottom of the wall it causes settlements in the wall and may lead to failure of the wall.

Example of masonry made of weathered, poor quality sandstone, which should be replaced.

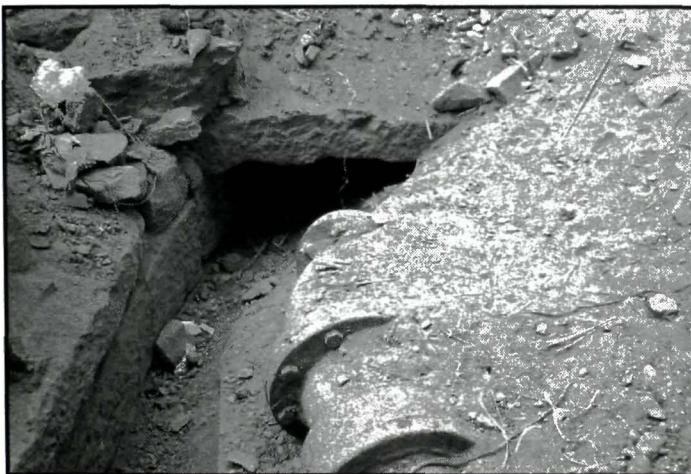
PHOTO 13.1

Water from the infiltration mentioned above causes seepage into the walls and into the sandstone beneath the walls. The sandstone is permeable and the water will evaporate from the walls. It is evident from the colour of the walls that many of the walls are dark in the lower parts due to moisture.

Stormwater outlets to the Mori are in many places blocked by new pipes, soil, and garbage.

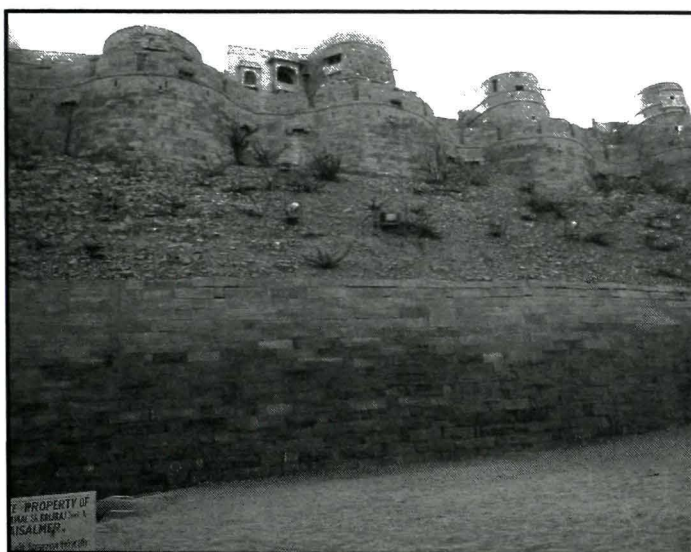
PHOTO 13.2.1

The pitching wall is 6-10 m high and is built as a dry masonry wall of sandstone on an excavated almost vertical slope into a clay-stone.

The lower part of the pitching wall is dark due to moisture.

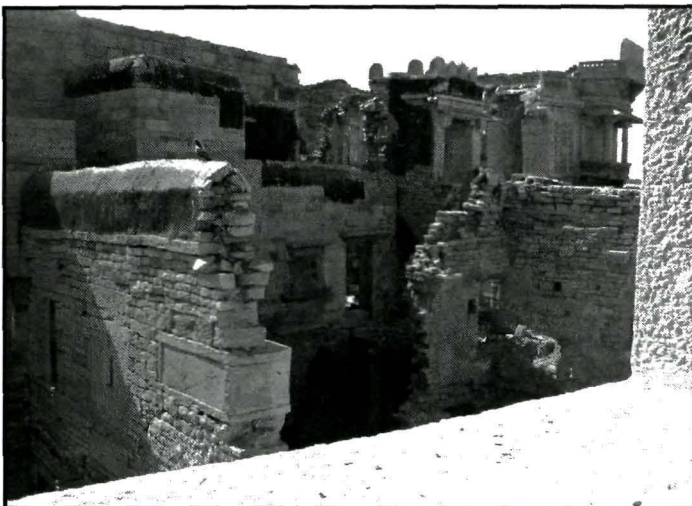
PHOTO 13.3

The foundations of some buildings within the Fort are probably made directly on clay-stone or on an extremely thin cap the overlaying hard sandstone. Here there is a risk that the rock will have disintegrated into soil and there will be settlements or collapses of the structures. This risk is particularly high in lower areas where foundations will be water soaked for long periods.
